Inspections by Bob, LLC
13121 Darnestown Road, Gaithersburg, MD 20878
(301) 208-8289
Fax (301) 926-6643

Decks: Unsafe at Any Age

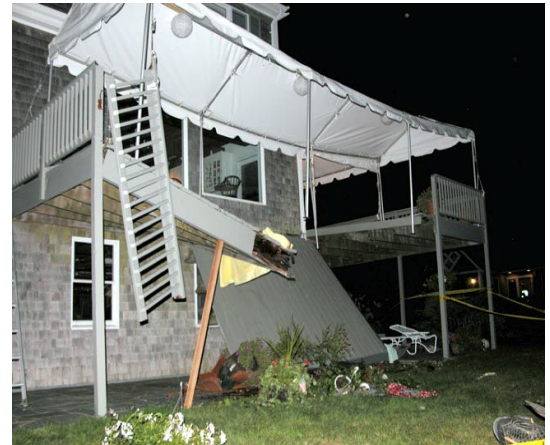
Ten partygoers were injured when this deck on Martha’s Vineyard collapsed in August 2003.

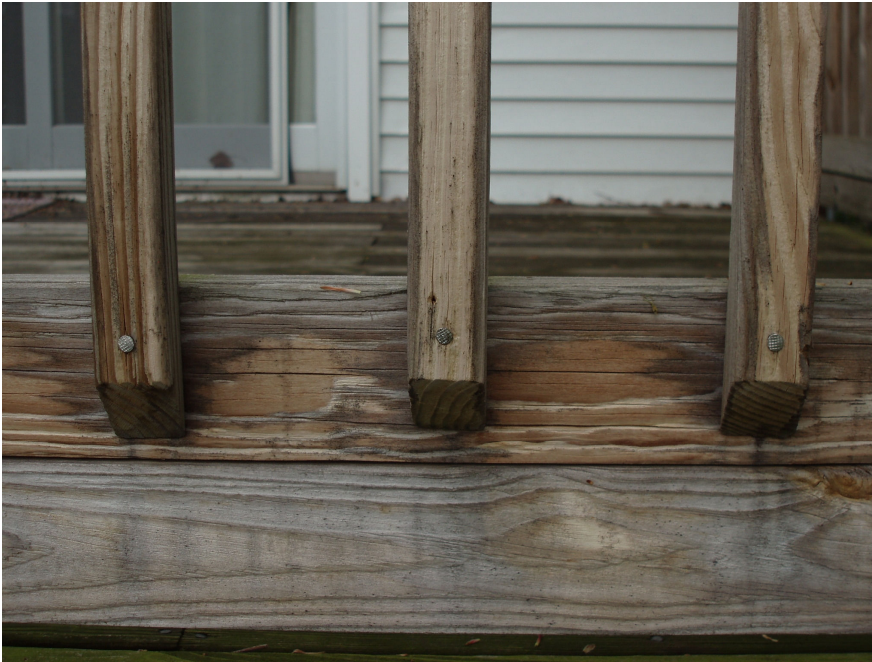
An adult falling into this railing could easily cause it to pull away from the deck, causing an accident.

The current code requirement anticipates the application of a 200-pound force applied to the top rail at any point. The force should not cause failure with near

There is no known documented attachment method using fasteners alone that withstood laboratory tests of a guardrail post connection to a simulated deck floor framing. Bolts, lag screws and screws, between connecting the post and deck members, all failed well below the 500-pound threshold needed to pass the test. Some

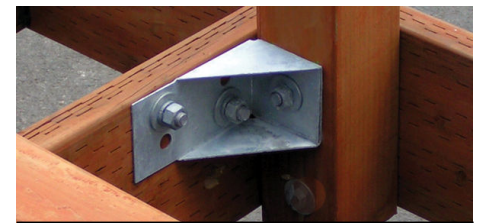
Example of a steel connectors that prevents railing post failures.

- The railing posts are continuous from the ground, i.e. through posts.
- The railing posts are connected to the structural deck members with an approved STEEL connector installed according to the manufactures specifications.

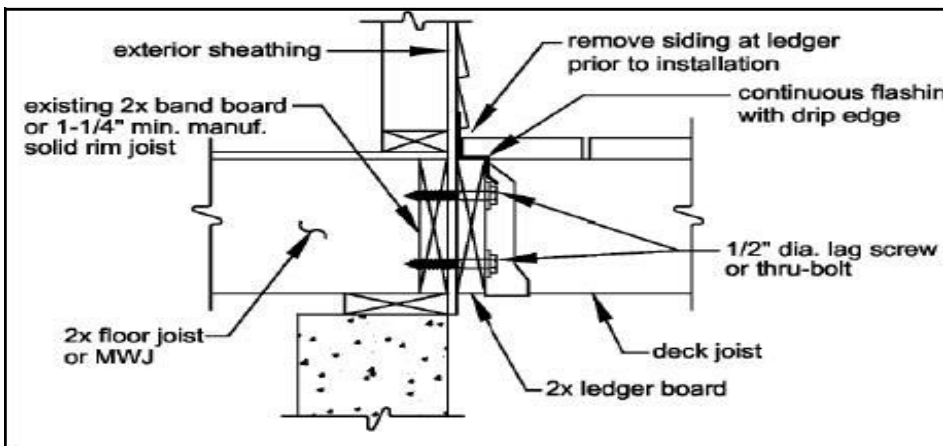
An example of a common deck to house ledger board detail from a county building web site

Flashing diverts moisture away from the load transfer points, i.e., where the bolts connect to the house. It has been shown that without flashing, the affects of moisture reduce the ability of the House’s member to “hold” the connection is substantially reduced over time, and eventually the connection has almost no remaining strength. A very small occupant load can cause a decayed

sized, carriage bolts or lag bolts, in the correct pattern. Regular screws can pull out, and nails are not acceptable at all. The deck must be through-bolted to the house, with sufficient bolts to support the load and must have washers to prevent pull through. Bolts “in a line” create ideal conditions for cracking and greatly weaken the supporting member.
